ENGINEER'S REPORT
of the
LEONIDES ROSARIO INCIDENT

Richard A. Colberg
Mechanical Engineer

LEONIDES ROSARIO INCIDENT**ENGINEER'S REPORT****OCTOBER 21, 2003****A. INTRODUCTION**

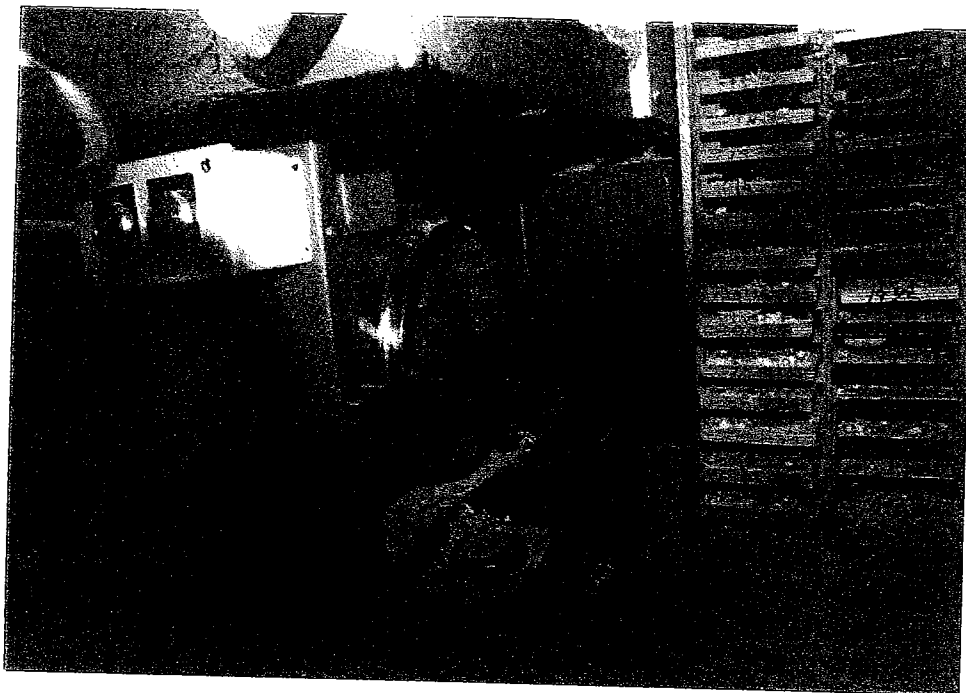
PHOTO #5

Photo #5 shows a close-up view of the newly-added front ON/OFF control. Immediately to the right of this control one can see the spindle elevation crank control. And, to the right of the elevation control is seen the original electrical control box for the shaper. Photo #6 shows a closer view of the front of this original electrical control box. Also seen are where the original buttons for starting, stopping, and braking were located.

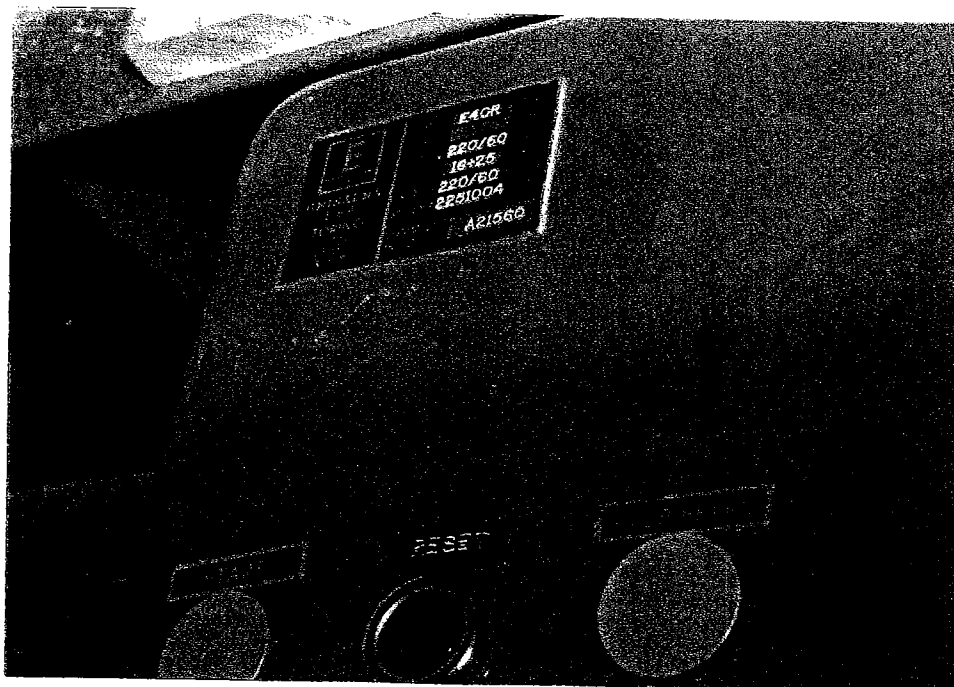
PHOTO #6

A second inspection was performed on February 10, 2003 with the singular purpose of trying to find an SCM serial number identification on the machine. None was found during my two inspections. There are various numbers stamped into a metal plate on the side of the motor control box seen in Photo #6, but none appears to be the machine serial number.

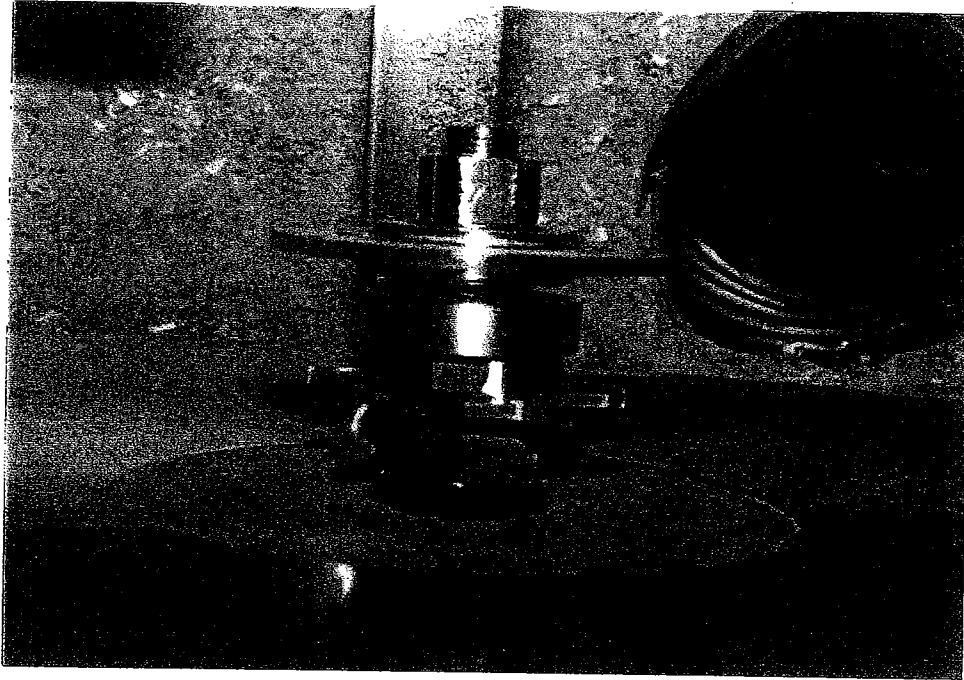
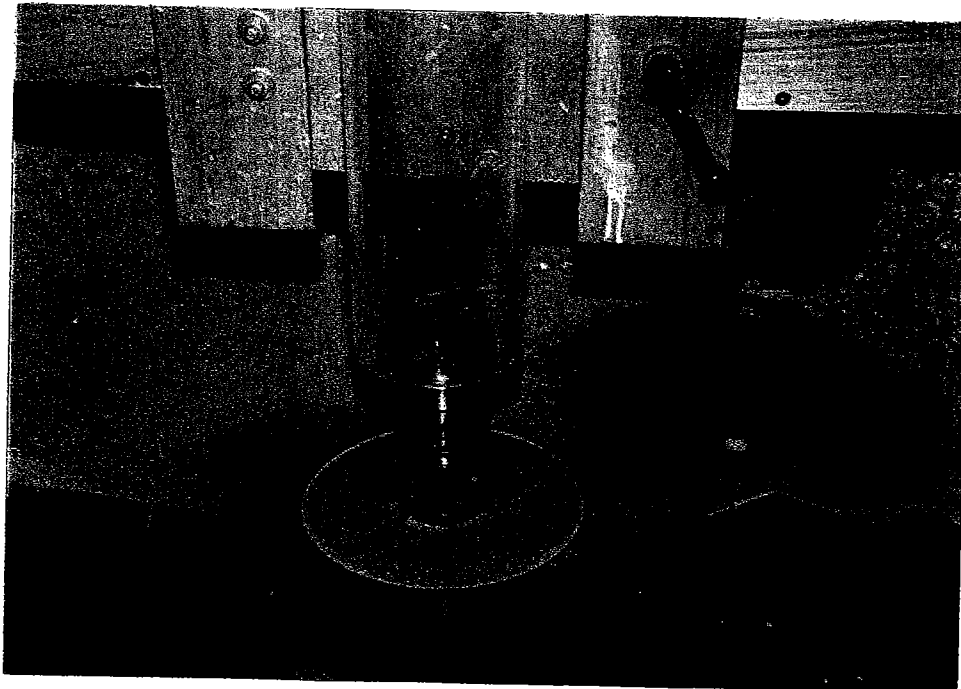
Shown in Photos #7 and #8 are disc and cylinder cutter guards as mentioned above. Neither of these guards was on the shaper at the time of Mr. Rosario's incident.

There is no testimony that the guarding requirements of ASA O1.1 or ANSI O1.1 were met by the subject shaper as-manufactured. There are no instructions on the subject shaper regarding the proper use of such guarding. Disc and cylindrical overhead guards were fabricated at local machine shops to the order of Meridian Products for the subject shaper. The cylindrical guard was fabricated after Mr. Rosario was injured. No overhead guarding was in use at the time of this incident. (Howe, Pgs. 87 & 90)
